FOUNDERS LANDING PARCEL 1 PART 201 DUE CARE PLAN

Soil Management Plan Founders Landing Parcel 1

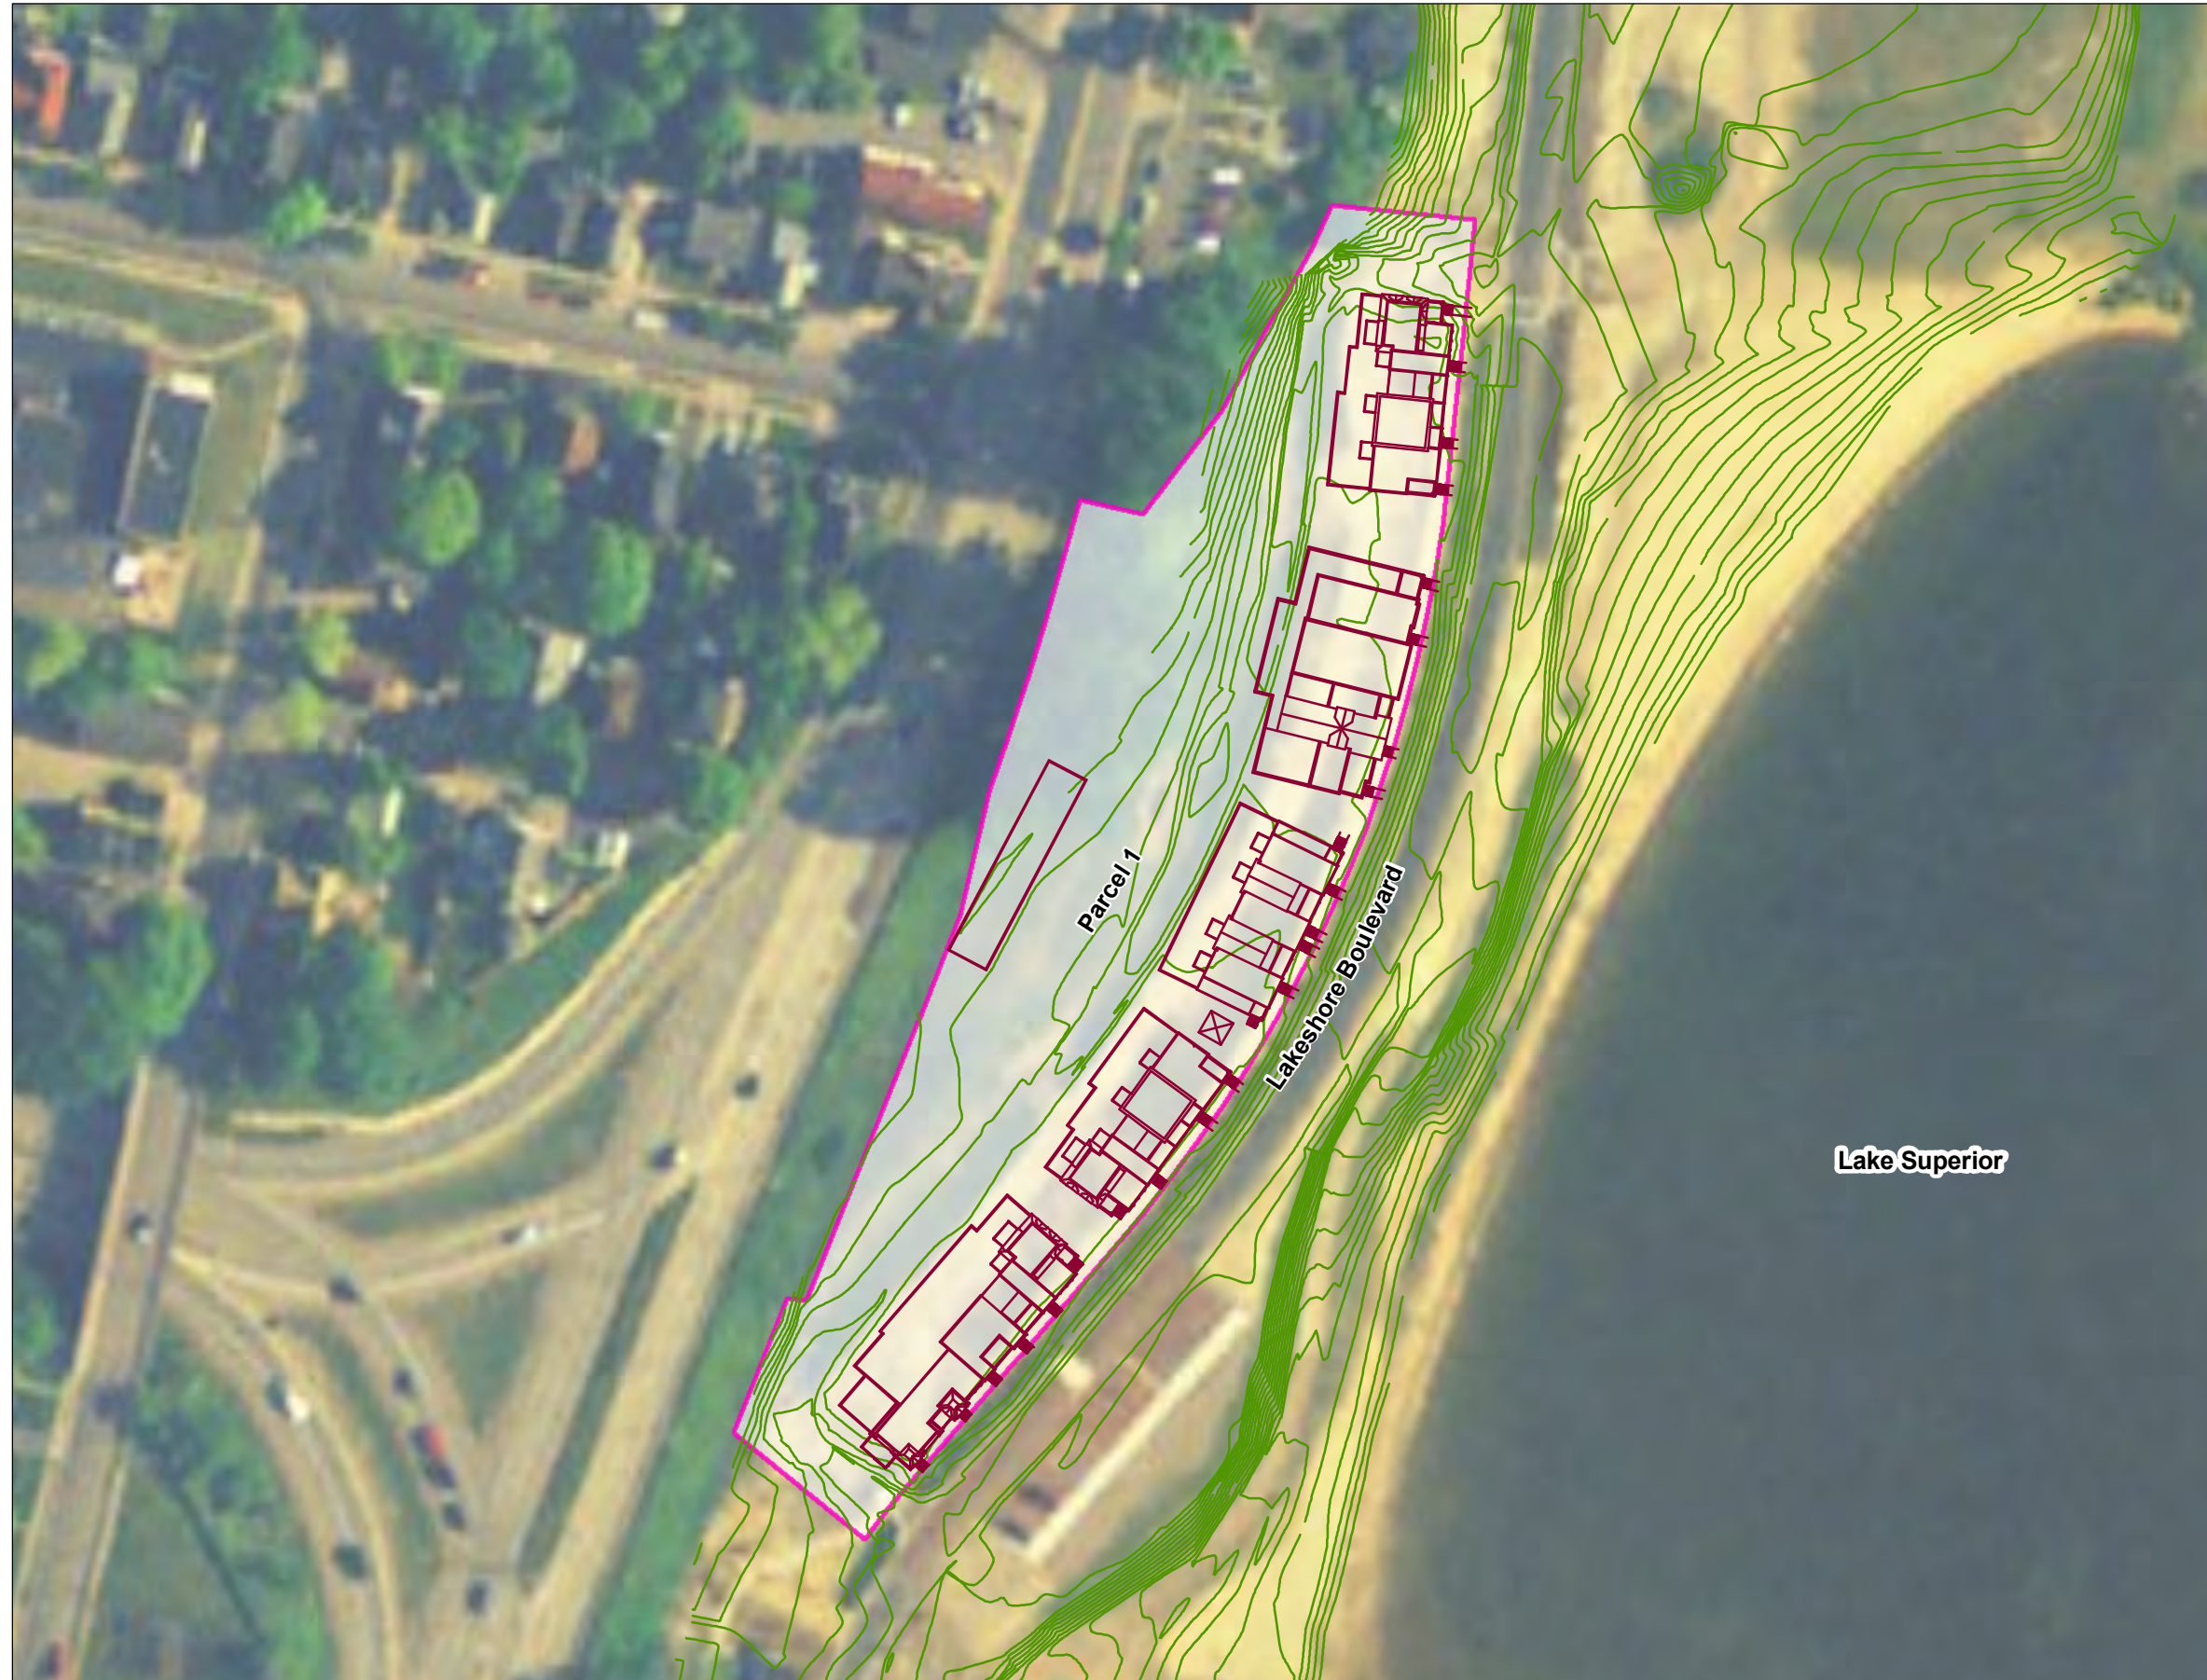
Figure 2
FOUNDERS LANDING
Site Development Plan

Parcel 1 property boundary

Data Sources:
Barry J. Polzin AIA, Architect
ESRI Imagery, i-cubed 2008

The Property contains underground utilities and no other structures. The City of Marquette has prepared the Property for development largely through grading, covering the Property with fill and constructing utilities through the Property and an extension of Lakeshore Boulevard along the eastern Property boundary. The intended future use of the Property is single and multi-family residences as shown in the Site Development plan (Figure 2).

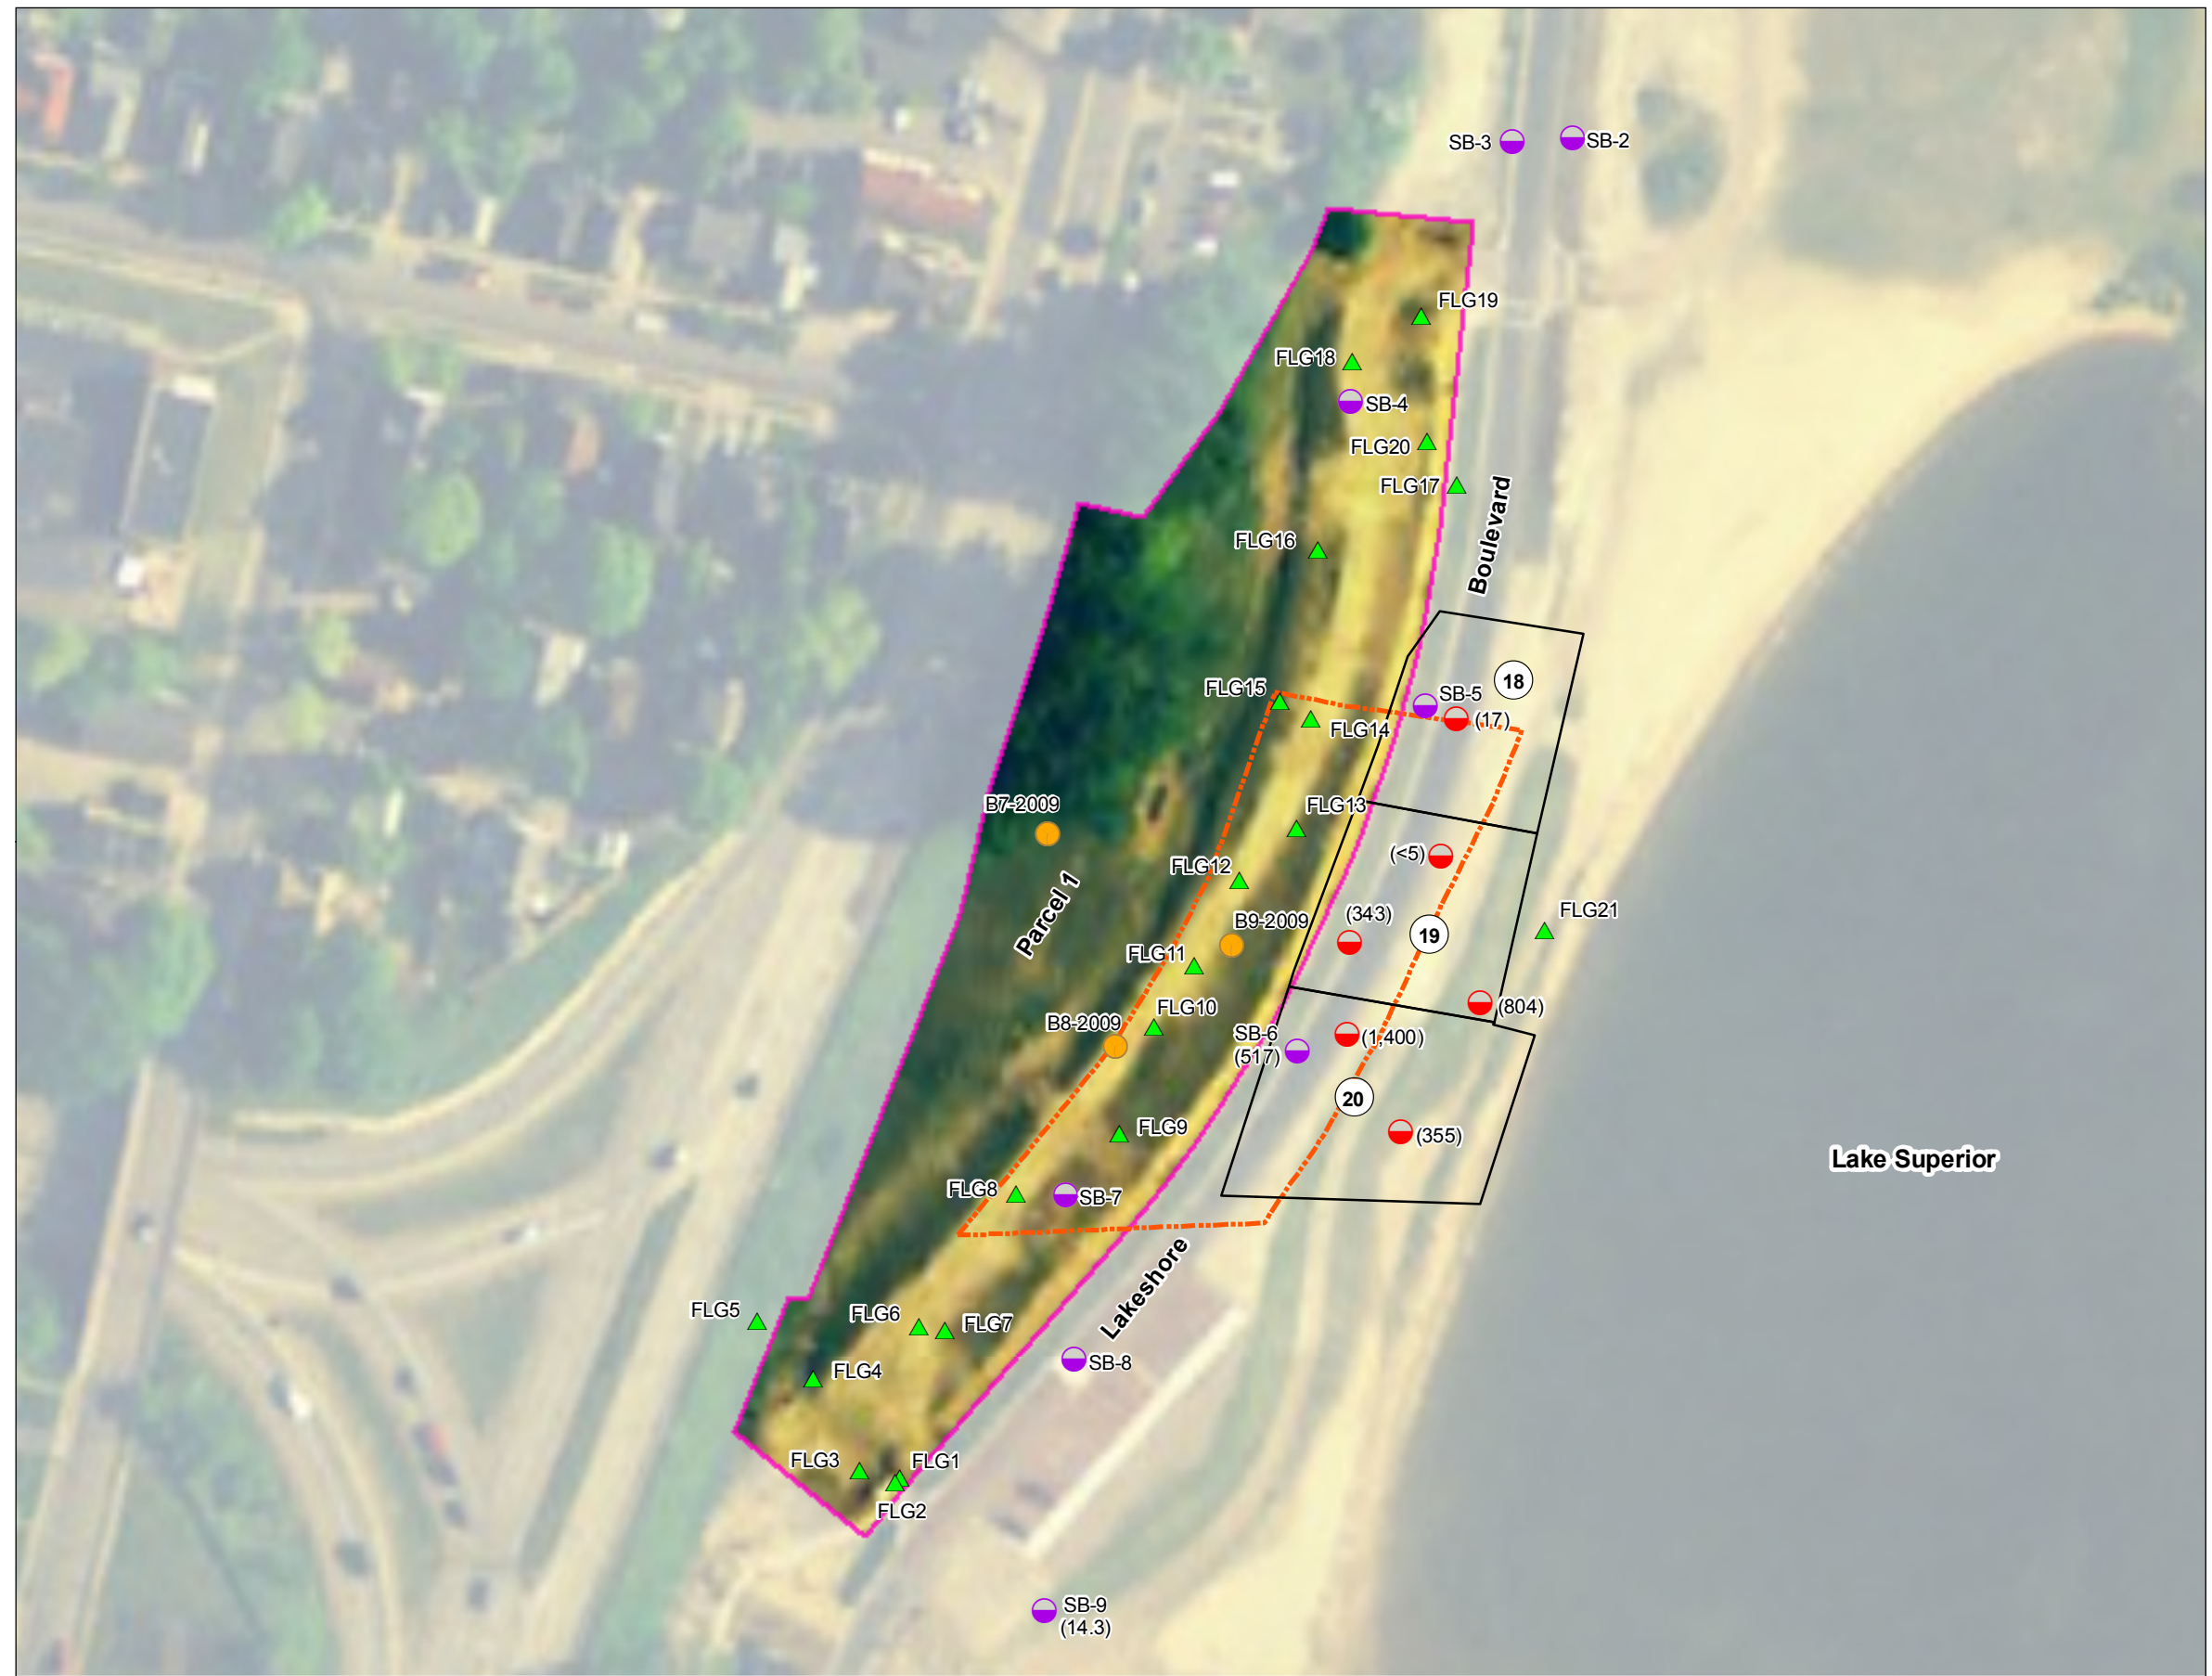
Figure 3
FOUNDERS LANDING
Parcel 1 and Historical Soil
Quality Data

- ▲ FLG 1 GPS point for BEA (2008)
- RI Soil sample (STS, 1995) (804) Lead concentration (mg/kg)
- City of Marquette BEA Soil Sample (Tri-Media, 2002) (517) Lead concentration (mg/kg)
- 2009 Soil Boring
- 18 Wisconsin Central LTD. Sample Grid
- Parcel 1 property boundary
- Area of known soil contamination Marquette South Rail Yard Phase I (Beckett & Raeder, 2003)

Each of the areas within the Site has had at least a limited investigation to address environmental conditions. Of particular importance to this BEA is investigation data associated with the South Tank Farm. Soil and groundwater contamination have been documented and reported to the Michigan Department of Environmental Quality. The degree of contamination in soil and groundwater samples collected from locations within the South Tank Farm is significant but no work was identified delineating the extent of these impacts west of the South Tank Farm's western property boundary. This boundary overlaps the eastern property limits of the Property subject to this BEA (Figure 3).
